MANDATORY
SERVICE BULLETIN

Service Bulletin No. 548
Engineering Aspects are
FAA Approved

SUBJECT: Diaphragm-Type Fuel Pump Inspection/Replacement

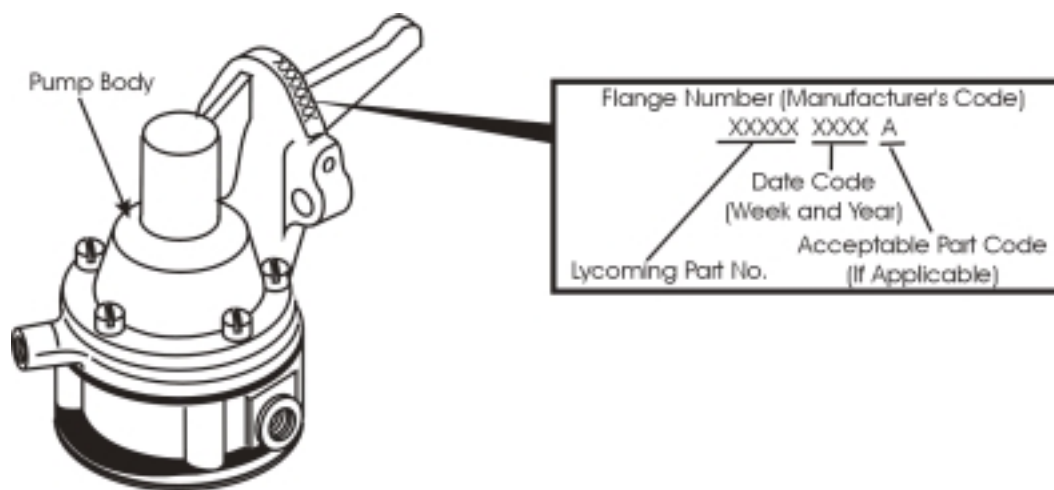
Figure 1

To identify affected pumps, check the manufacturer's code scribed on the flange of the pump (See Figure 1). If the first five digits are 15472, 15473, or 16335, and the 6th through 9th digits are 3900, 4000, 4100, 4200, 4300, 4400, 4500, 4600, 4700, 4800, 4900, 5000, 5100, 5200, 0101, 0201, 0301 or 0401, the pump is affected and must be replaced.

If the letter "A" is marked as a suffix to the date code, the pump has been brought into conformity and need not be replaced.

If your Textron Lycoming engine has a diaphragm-type fuel pump with Lycoming P/N LW-15472, LW-15473, or LW-16335 installed, and has a date code of 3900 through 0401, the pump must be replaced within the next 100 hours of operation or 180 days from the date of this Service Bulletin, whichever occurs first.
