# SERVICE INSTRUCTION

Service Instruction No. 1508  
Engineering Aspects are  
FAA Approved

SUBJECT: Magneto Attachment

MODELS AFFECTED: All Lycoming IO-360-A1B6D and IO-360-A3B6D engines installed in Mooney M20J-201 aircraft.

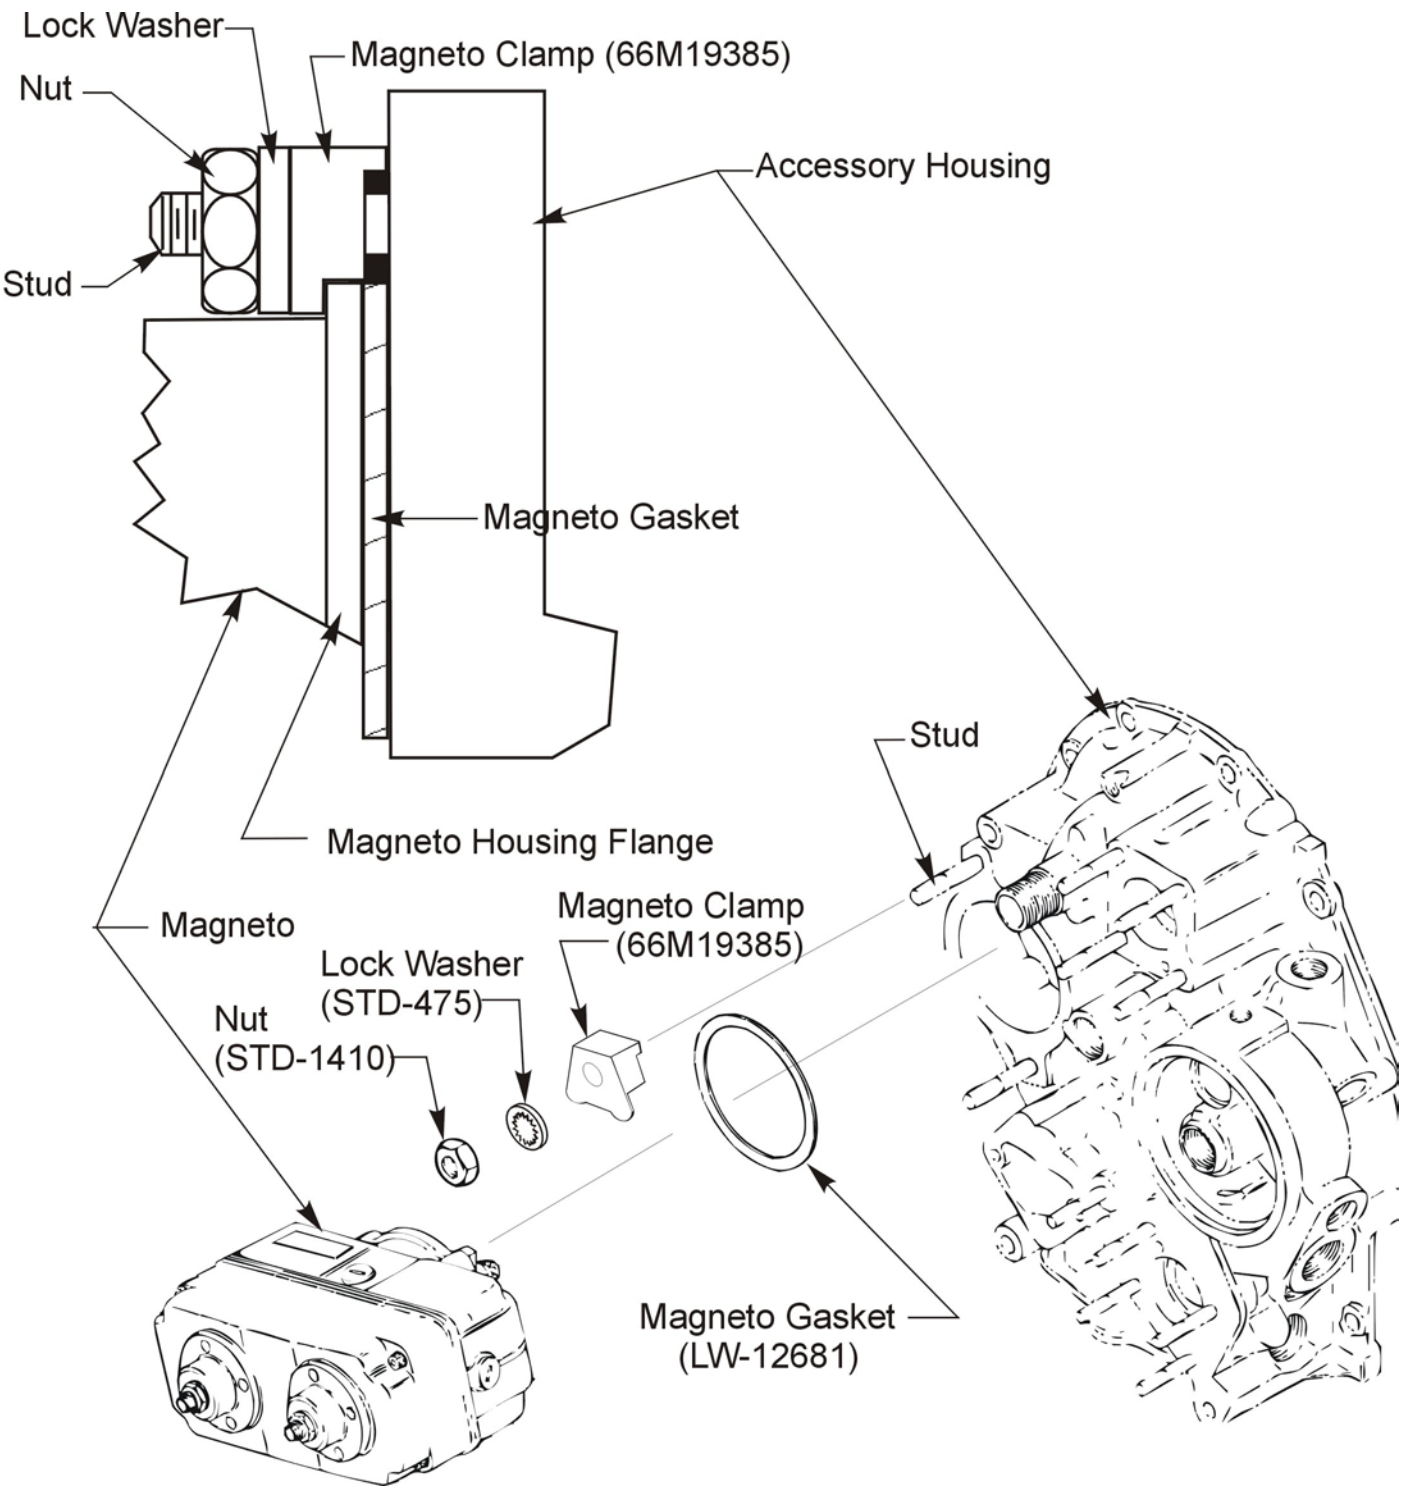
Figure 1.

In the Mooney M20J-201 there have been reports of the hardware attaching the dual magneto to the studs in the engine accessory housing becoming loose after maintenance in the field. It is possible that during magneto maintenance, such as timing changes or checks, the attachment nuts are not being torqued to specifications or that hardware has not been installed properly.

1. Inspect to be sure the correct gasket (P/N LW-12681) is being used. The gasket should be circular and no part of the gasket should extend beyond the flange of the magneto housing.
2. Be sure that the magneto clamps are P/N 66M19385 installed as shown. No other clamps are acceptable.
3. If an attaching nut is removed, install a new P/N STD-475 internal tooth 5/16 lockwasher as shown.
4. Be sure that the P/N STD-1410 attaching nuts are torqued to 17 ft.-lbs. (204 in.-lbs.).

To access the nuts and achieve the specified torque, it is helpful to use a torque wrench fitted with a wobble head extension.
